RIPPOWAM RIVER BASIN
STAMFORD CONNECTICUT

N. STAMFORD RESERVOIR DAM
CT. 00048

PHASE I INSPECTION REPORT
NATIONAL DAM INSPECTION PROGRAM

FEBRUARY 1979

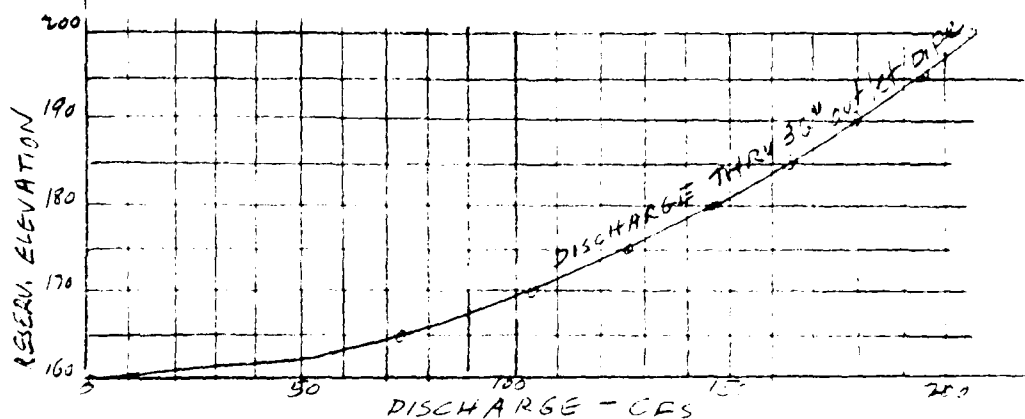
FIGURE 1
SHEET D-3

A spillway discharge curve has been prepared for the spillways as they presently exist. A discharge curve for outflows through the spillways and over the dam and dike are shown on Figure 1, Sheet D-3, Appendix D. Computations are shown on Sheet D-4. Pertinent discharges are as follows:

With the flashboards in place, the capacity of the spillway is accordingly reduced. A discharge curve for the spillway with 12 in. flashboards installed is shown on Figure 1, Sheet D-3. It will be noted that, with the reservoir level at the top of the gravity dam, elevation 200, the spillway discharge will be about 4,800 cfs, or 65 percent of that for the unobstructed crest. With the reservoir at the top of the earth dike, elevation 202, the spillway discharge will be about 10,400 cfs. or 70 percent of that of an unobstructed crest.
